METALLURGICAL MINUTES

Biological Corrosion of Metals

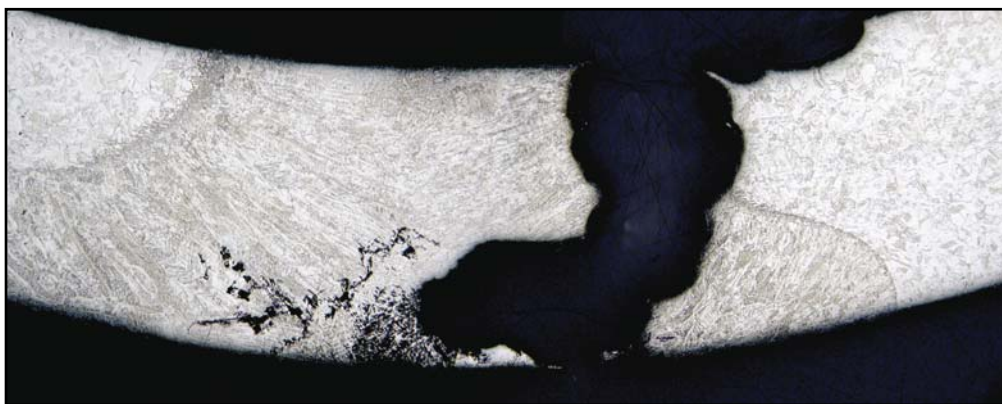
Classic hallmark of a widespread MIC failure type. This cross-section of a Type 304 stainless steel heat exchanger tube failed by MIC at the longitudinal seam weld, perforating the 0.065” tube wall. MIC began at the tube ID due to an anaerobic bacteria species introduced through incomplete drying following hydrostatic testing.

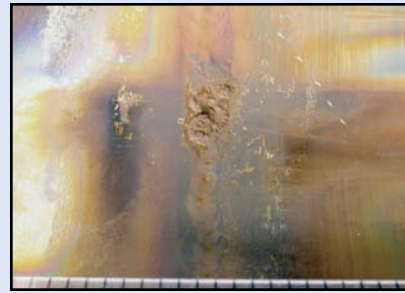
MIC Failure Example 1

This sequence shows several steps in the analysis of pitting corrosion in stainless steel tubing from a water bottling plant. The plant processed purified water, normally a media relatively immune to

MIC. However, hydrostatic testing performed during installation of the process piping introduced anaerobic bacteria which adhered to several tube ID welds and adjacent areas, resulting in perforation of the tubes (above).

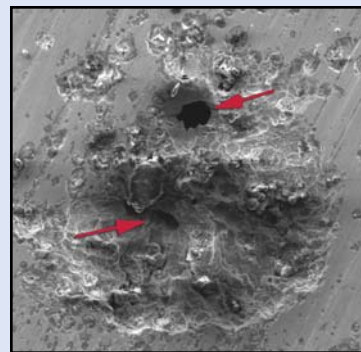
The pits were examined using a Scanning Electron Microscope which revealed biological adhesions in and around the pits. Several entries leading to apparent sub-surface voids were also observed (at arrows).

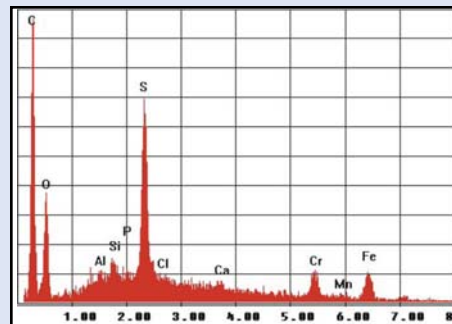
Micro-chemical analysis of the biological adhesions, by Energy Dispersive Spectroscopy (EDS), identified high levels of carbon (C), oxygen (O) and

sulfur (S). These elements are consistent with sulfur reducing and oxidizing anaerobic bacteria species implicated in MIC.

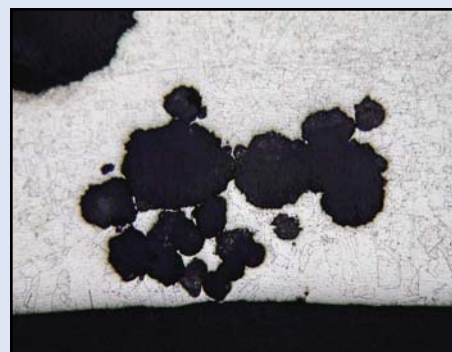
Polished cross sections through the pits revealed internal cavities in the 0.060" thick tube wall, again, a hallmark of anaerobic bacteria which adhered to the tube ID surface

and migrated to these oxygen depleted cavities formed by corrosive attack from their acidic by-products. Because MIC usually initiates at the ID of tubing, extensive corrosion and, eventually, perforation occurs before any visible evidence of attack is apparent externally.

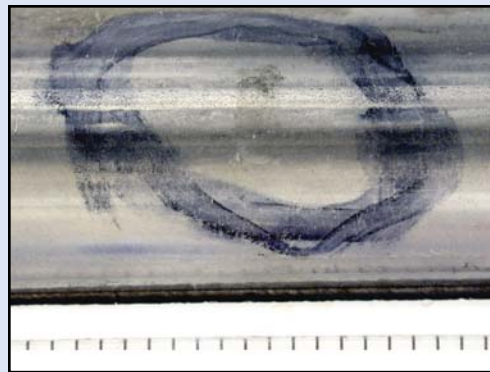
MIC Failure Example 2

“Weeping” of fluid from systems is a precursor to full blown perforation by MIC. The source of this “weeping” is often a subtle

discoloration of the tube or vessel surface as shown at the center of the circled area.

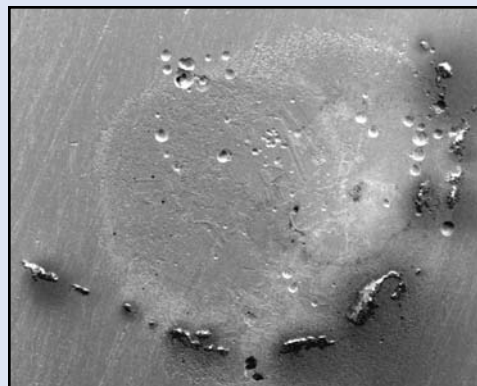
Examination of these features by Scanning Electron Microscopy reveals fine micro-pitting and a “sponge” like morphology as the interior MIC attack

nears the outer surface.

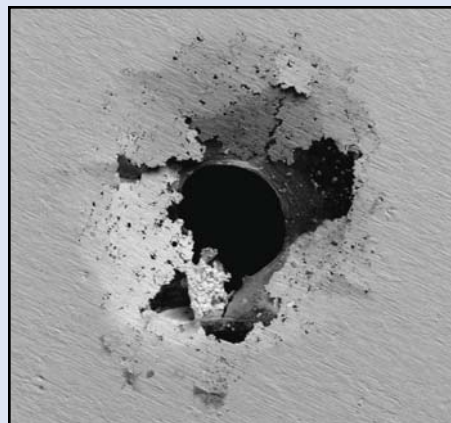
Probing this “sponge” like surface collapsed the thin crust of remaining metal at the surface, exposing the sub-surface cavity created by anaerobic bacteria and their sulfuric acid by-product.

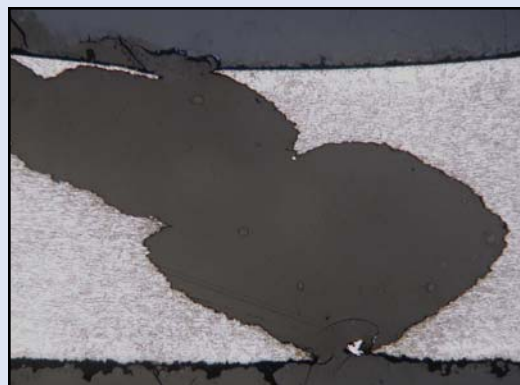
A cross section of the discolored feature reveals the extent of corrosive MIC damage which has

penetrated completely through the material wall thickness.

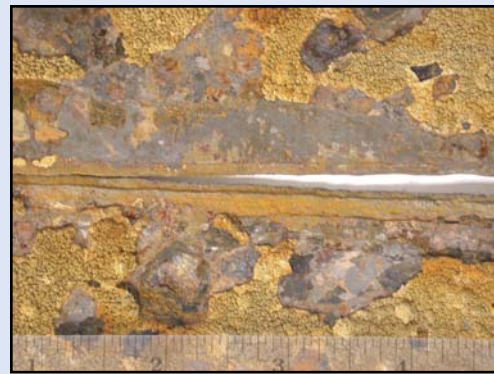
MIC Failure Example 3

Pitting and general corrosion are both associated with MIC, sometimes in the same corrosion failure. The interior of this carbon

steel storage tank exhibits extensive general corrosion.

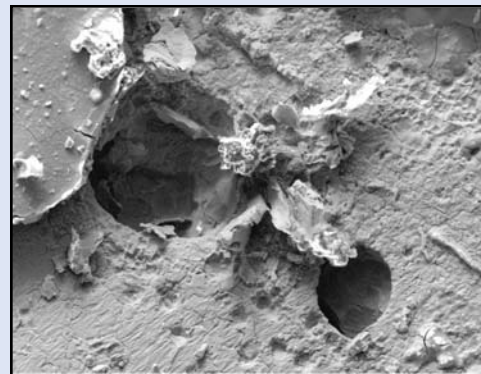
The interface of the tubercle with the metal substrate beneath it offers an oxygen depleted environment that is ideal for anaerobic MIC bacteria.

Ultrasonic cleaning of a section of the corroded tank to remove the tubercles revealed small deep pits suggesting connected sub-surface cavities consistent with sulfur reducing bacteria.

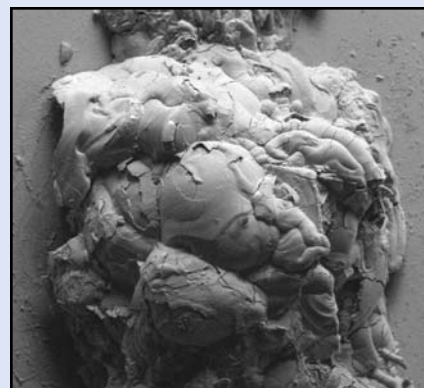
Examination by Scanning Electron Microscopy revealed numerous tubercles on the corroded tank ID surface. Tubercles are found in association with MIC producing iron oxidizing aerobic bacteria.

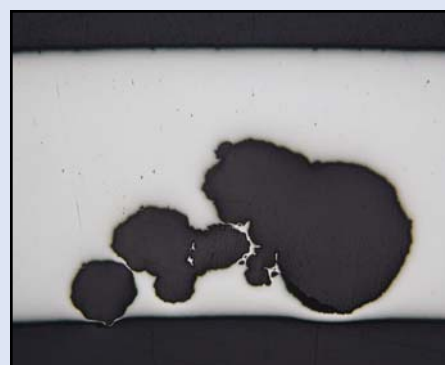
Cross sections of the tank confirm anaerobic MIC bacterial activity by the presence of characteristic sub-surface voids. This failure demonstrates the symbiotic relationship often found between

two or more MIC implicated bacterial species, producing two corrosion modes (general and pitting) in a single corrosion failure.
