METALLURGICAL MINUTES

When "In Spec" Doesn't Work

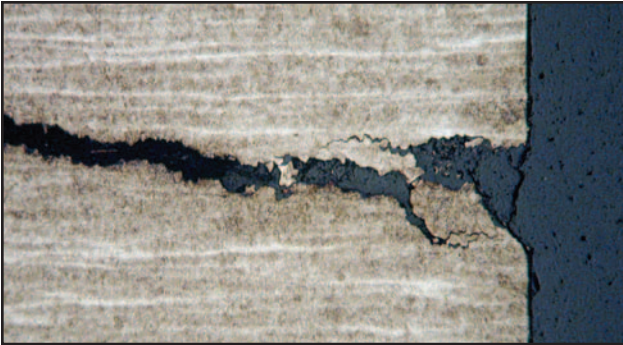
By any criteria the shaft was within specification. However, the carbon is at the maximum specified value, manganese is near the maximum specified value and chromium is in the upper third of the specified range. The maximum or near maximum values of this combination of elements, although within spec, result in a higher than typical hardenability when this material is heat treated. The result of this higher than typical hardenability was an unacceptable percentage of quench cracks during a heat treating procedure that had been used successfully in the past on axle shafts with more typical SAE 4140 chemistries. Many of these cracked axle shafts were placed in service, resulting in short term failures.

Optical photomicrograph of polished cross section through the cracked axle shaft. 40X

result, we often recommend a change in material or tightening of the material specifications which provide a significant savings "up front" before processing or service failure costs occur.

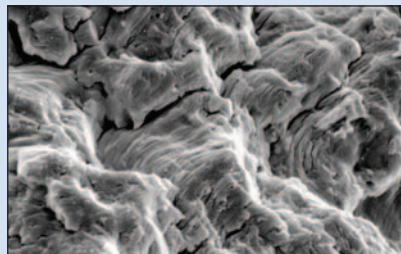
- Failure Analysis of bicycle carrier rack. Electron microscopy revealed fatigue fracture as the failure mode. Alternate material or design options were provided.

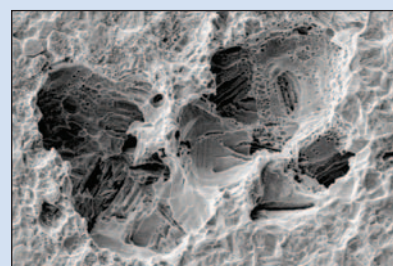
- Corrosion Analysis of Type 304 stainless steel tubing, taken from stored inventory. SEM and EDS Analysis revealed high levels of chlorides which evolved to hydrochloric acid when exposed to moisture from temperature driven condensation.

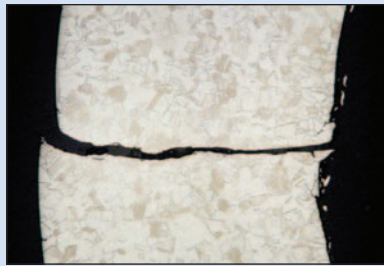
- Failure Analysis of Type 316 Stainless Steel tubing fabrications from food processing plant. Investigation determined failure resulted from stresses induced during the manufacture of the tubes.

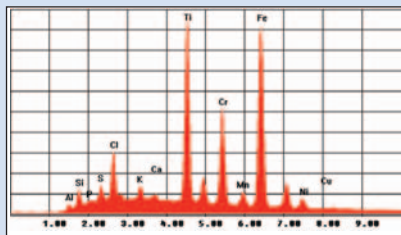
- Analysis of powder coated fasteners. Coating adhesion failure resulted in corrosion of the fasteners however, distortion of the fastener by over torquing during installation rather than any deficiency in the powder coating, was identified as the root cause of the failure.

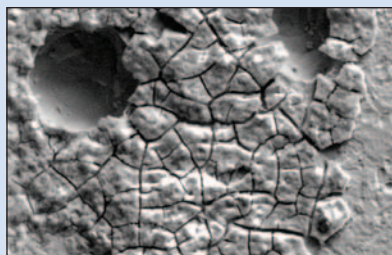
- Corrosion analysis of pitted Type 304 Stainless Steel manifold from an industrial heat exchanger. Analysis of deposits associated with corrosion pits were matched to an unauthorized cleaning solution used by a plant employee.

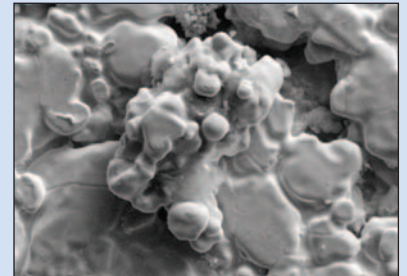
- Failure Analysis of heat treated vehicle suspension component. Examination of the fracture using one of our Scanning Electron Microscopes revealed incipient melting resulting from a poorly controlled heat treating process which exposed the component to temperatures near the material's melting point.

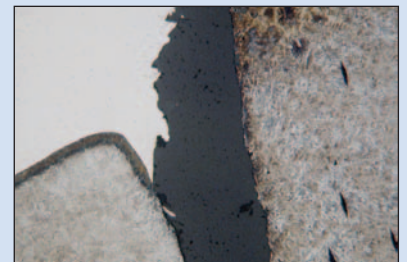
- Failure Analysis of welds in sports stadium seat frames, resolved by recommended changes in the welding parameters.

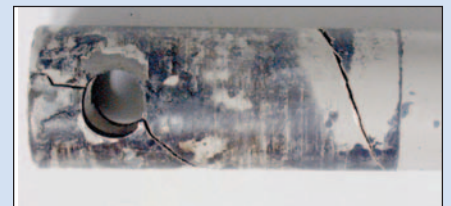
- Analysis of failed ATV accessory carrier frame. Evaluation revealed fatigue failure initiating at poorly finished cross drilled holes. Options of a material substitution or an added chamfering operation were provided.
