METALLURGICAL MINUTES

Fatigue Failure

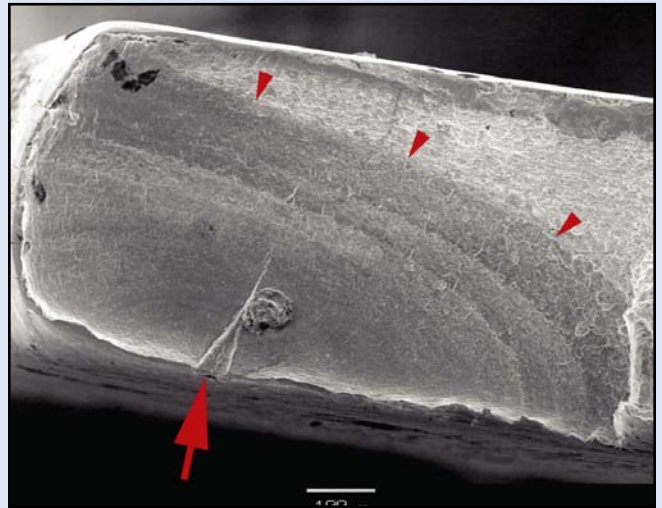
There are three stages in the life of a fatigue failure: **1 Initiation**, **2 Crack Growth (propagation)**, and **3 Final Fracture**. These stages are illustrated in the SEM image of a fractured rectangular wire above. The Initiation is indicated by the large red arrow at the lower left. The area of progressive Crack Growth extends from this arrow to the line indicated by the three smaller red arrows. Final Fracture, the point at which the remaining intact cross section of the wire could not sustain the next cyclic stress load – “the straw that breaks the camels back” – and complete fracture occurred, is the light area above the three arrows. This fracture is an example of **bending fatigue** (in one direction) initiating from a single point of origin.

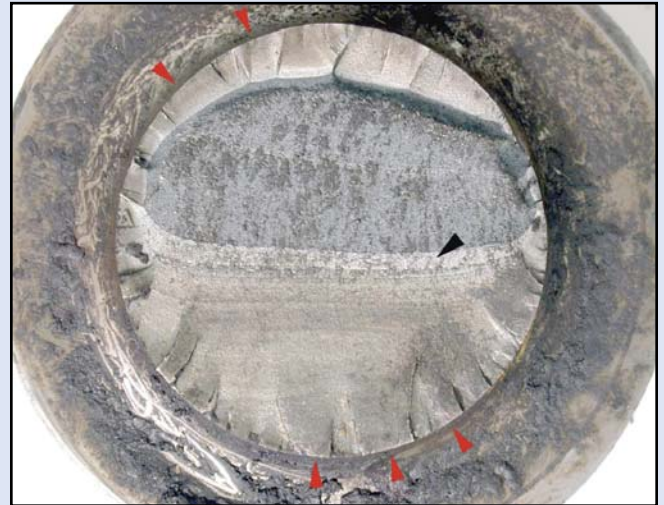
The fractured crane lifting hook above is an example of **reverse bending fatigue** (back and forth in two directions). In this case, the major bending stress was applied from the bottom of the fracture as oriented in this photo, and a minor stress from the top. The darker gray area indicates final fracture in a single stress cycle. The thin horizontal band at mid fracture indicates a significant "jump" in the fracture progression that occurred in the cycle proceeding final fracture which almost, but not quite, resulted in complete fracture. This fatigue fracture initiated from multiple origins. Multiple origins are indicated by the steps, or "ratchet marks", at the outer diameter of the fracture indicated by the arrows. Ratchet marks occur when multiple fatigue cracks initiate at slightly different planes on a component's surface. As these multiple cracks progress into the component, they eventually join into a single fracture plane as show above.

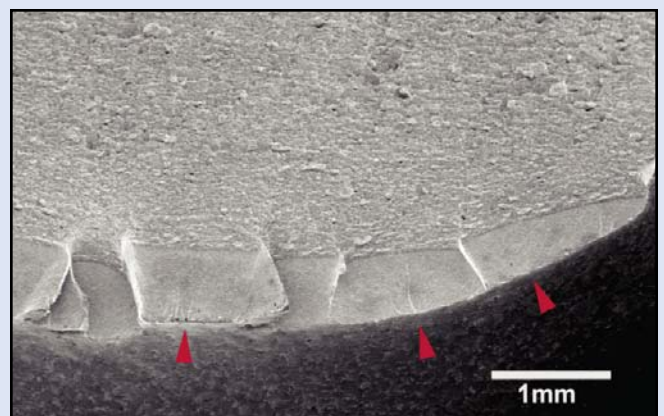
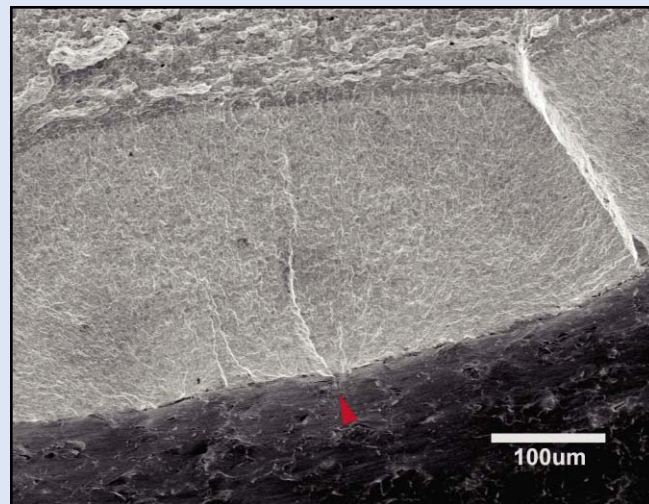
Rachet marks resulting from multiple fatigue origin locations are shown at high magnification in these images (see image below and at the top of the adjacent column) taken on our Scanning Electron Microscope (SEM). Fatigue cracking penetrated only a short distance into this NASCAR Racing suspension component before

it failed completely in a single load cycle. As a result, the multiple origin fatigue cracks never progressed far enough to coalesce into a single fracture plane. Several of the individual origin sites are indicated by arrows.

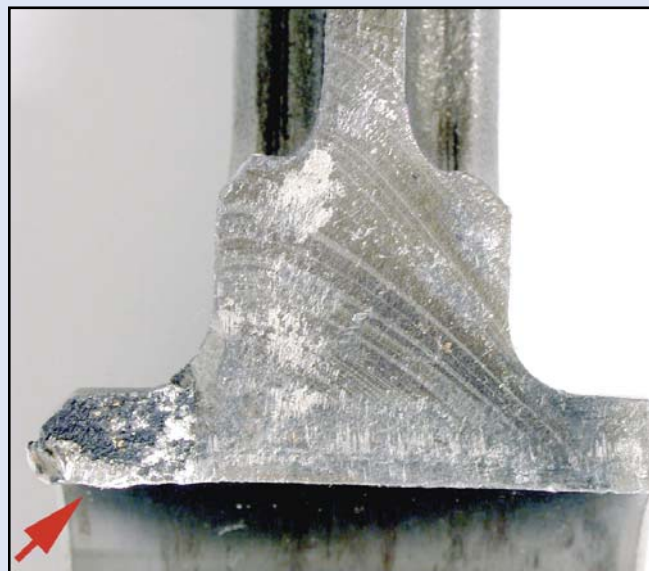
The diagonal bands exhibited by the fatigue fracture of this compressor connecting rod are commonly called “arrest lines”. These indicate a change in the frequency of cyclic stresses, such as “stop-start” sequences, changes in RPM, or variations in load. The initiation site at the crankshaft journal bore (arrow) is heavily damaged. This is not uncommon in fatigue failures. As the first location to crack, the initiation site is exposed to potential relative movement of the two sides of the crack during propagation. This presents a significant challenge to the analyst in determining the root cause of fatigue cracking.

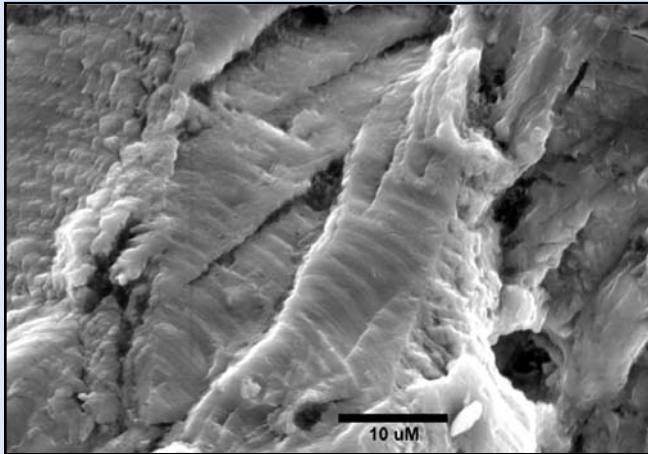
Fatigue fractures exhibit distinct features, called striations, when viewed at high magnification using Scanning Electron Microscopy. Striations appear as relatively evenly spaced parallel lines. Each striation is actually a shallow crack that results from a single load, or stress, cycle. Repetition of these cycles produces an advancing repetition of shallow cracks as shown above in this fatigue fracture in a hydraulic valve body. This process is characterized by the term, “fatigue crack propagation”.

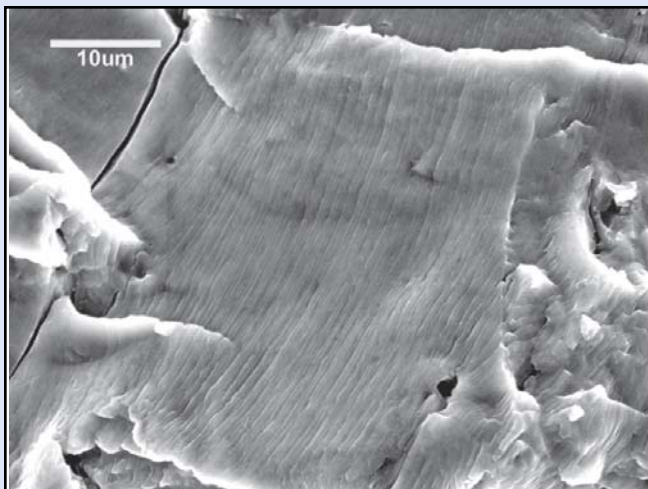
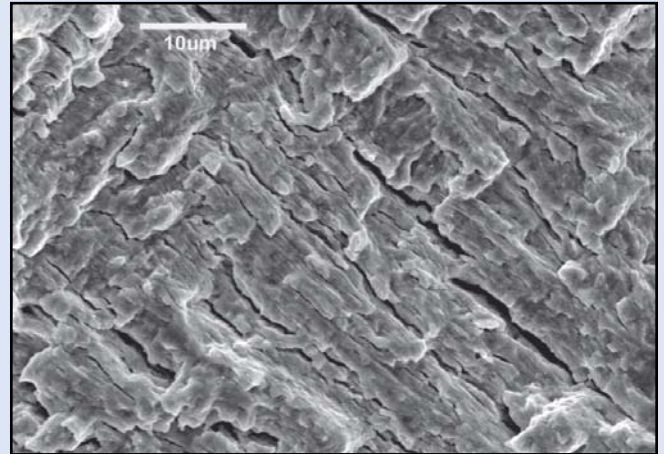
The appearance, or morphology, of fatigue fracture striations varies depending on the magnitude and frequency of the applied load and the physical characteristics of the affected component such as hardness, microstructure and chemical composition of the alloy. These SEM images illustrate fatigue striations in an aluminum valve body (image below) and an alloy steel high pressure hydraulic cylinder (image at the top right of the adjacent column).

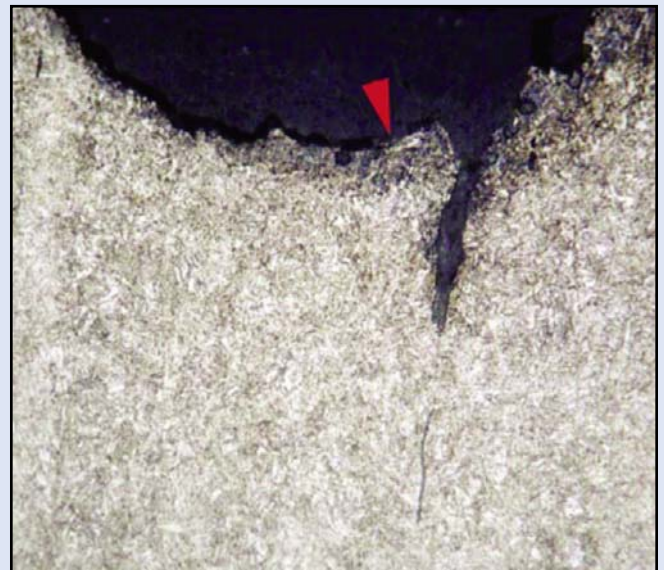
In some cases, the root cause of a fatigue failure can only be discovered by an analysis of internal characteristics of a component at the crack location. In this example below, a metallographic cross section revealed decarburization (dark phase at arrow) of the surface of a steering arm due to faulty heat treating. This carbon depleted layer has significantly reduced hardness and strength, as well as residual tensile stress, conditions highly conducive to fatigue crack initiation.

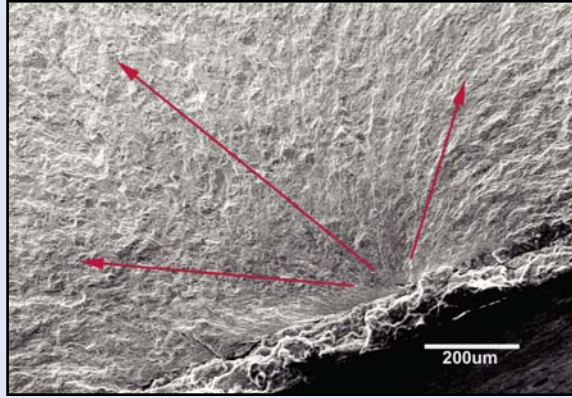
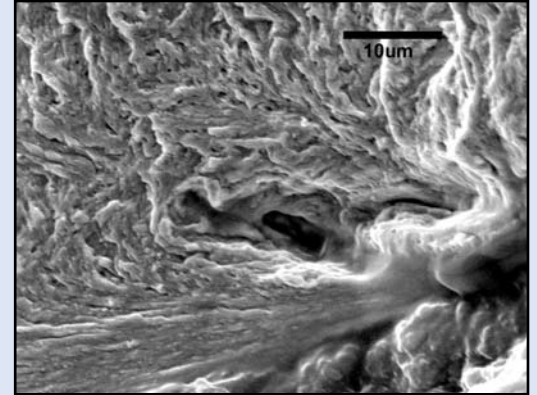
Other types of internal defects which act as initiation sites for fatigue are apparent on the fracture surface. Examination of this brake return spring by SEM revealed fracture features which radiate from a single initiation point. Viewed at higher magnification, this initiation point exhibits a void containing a non-metallic inclusion which acted as a stress concentration.
