METALLURGICAL MINUTES

When "In Spec" Doesn't Work

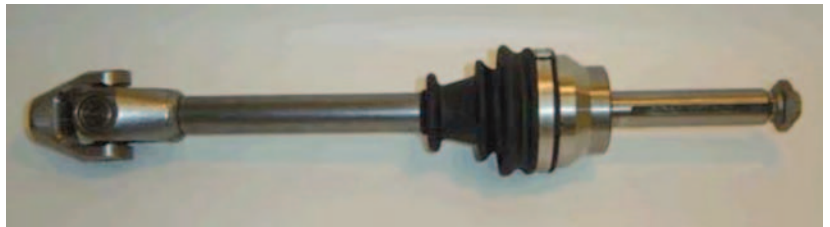
One of the first questions that must be answered in any failure analysis is "Was the part made from the specified material?" If the answer is "yes", the analyst may be tempted to go off in another direction in search of the cause of a failure. Our recent analysis of a failed axle shaft demonstrates that a more careful evaluation is prudent even when the chemical analysis is "in spec".

The axle shaft was specified to be made from SAE 4140 alloy steel. The elements, their percentages, and the results of chemical analysis of the axle are shown below:

By any criteria the shaft was within specification. However, the carbon is at the maximum specified value, manganese is near the maximum specified value and chromium is in the upper third of the specified range. The maximum or near maximum values of this combination of elements, although within spec, result in a higher than typical hardenability when this material is heat treated. The result of this higher than typical hardenability was an unacceptable percentage of quench cracks during a heat treating procedure that had been used successfully in the past on axle shafts with more typical SAE 4140 chemistries. Many of these cracked axle shafts were placed in service, resulting in short term failures.
