Metallurgical Minutes

Brittle Fracture

Elasticity, Toughness and Liberty Ships

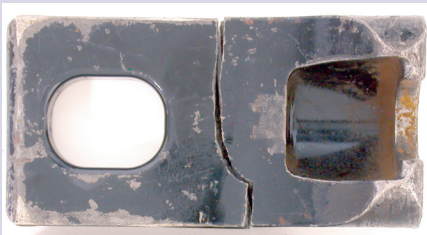
- Brittle fractures don't exhibit permanent plastic deformation such as bending, twisting or stretching. Often the two halves of the fracture can be fit back together like interlocking puzzle pieces as shown above.
- The fracture surface is usually approximately perpendicular to the direction of the tensile stress that caused the fracture although compound stresses exerted from multiple directions may result in variations.
- The fracture surface morphology often, but not always, exhibits a "flow pattern" that leads back to the point of fracture initiation. In the brittle fracture example shown below, the fracture initiated from an internal defect and propagated outward from there.

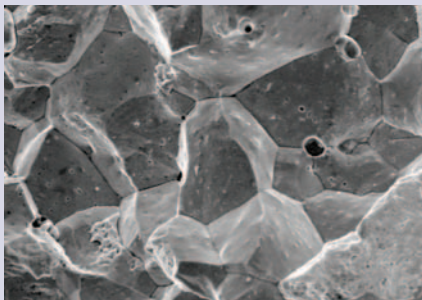
Intergranular brittle fracture in steel magnified 1000 times using a scanning electron microscope (SEM). In this fracture mode the individual interlocking crystals, or grains, that make up the microscopic structure of the metal are apparent and separation, or fracture, occurred at the interfacing facets of the grains.

- The microstructure of steel (and virtually all industrial metals) is composed of microscopic interlocking crystals, or grains. When examined at high magnification using a scanning electron microscope, brittle fractures are either intergranular or transgranular. Using a brick wall as a metaphor, this is equivalent to fracture of the wall between the bricks (intergranular), or fracture through the bricks (transgranular).

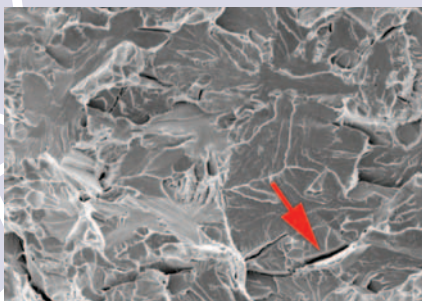
Transgranular brittle fracture in steel magnified 1000 times using SEM. In this type of brittle fracture, the fracture propagates through the grains, exposing an individual fracture surface on each grain. The boundaries, or interface, at the facets where the interlocking grains meet is visible at several locations, with a typical example indicated by the arrow.

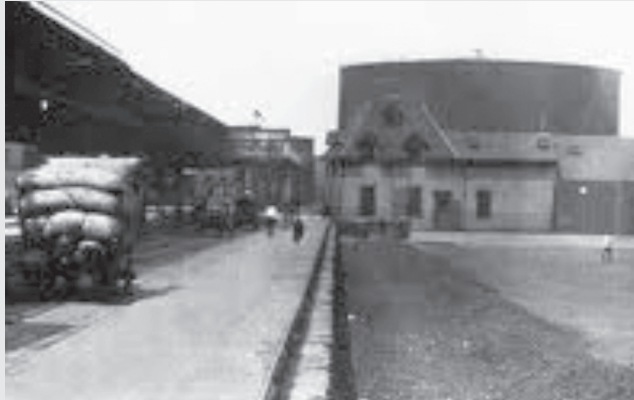
Since no one expected the catastrophic failure that resulted in the Boston Molasses Disaster, photos of the actual storage tank are difficult to confirm. This image, however, appears to be from the appropriate time frame and the dimensions of the tank in the background are consistent with the failed tank.

The tank was made from riveted cast iron plates. The “engineer” who designed it had no formal training and no testing was done before it was put into service. The instantaneous and explosive nature of the failure points strongly to brittle fracture as the mode of failure. However, the limited available knowledge of failure analysis at the time resulted in multiple theories as to the root cause, which has not been conclusively resolved to this day. These include insufficient strength due to poor design, pressure build up in the tank due to fermentation of the molasses, and overload resulting from the DBTT of the cast iron plates.

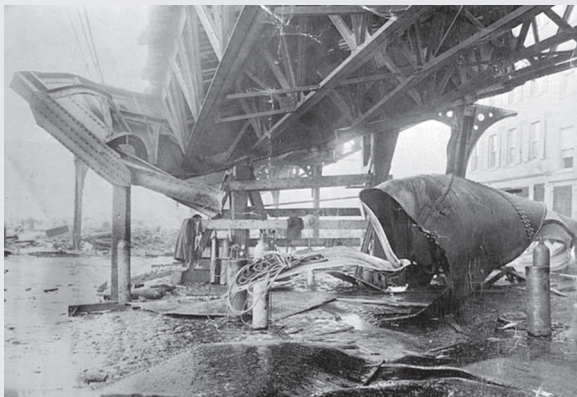
Destruction of the elevated train overpass after impact by sections of the storage tank and the tidal wave of molasses that followed. Although not confirmed, the twisted piece of riveted metal plates at the right may be part of the tank.

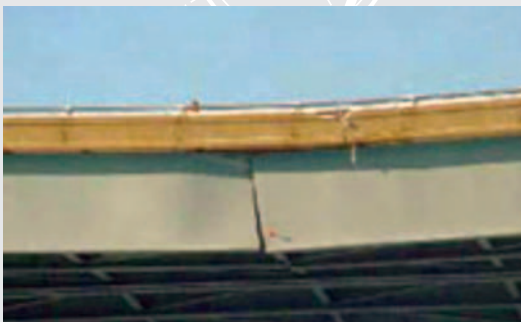
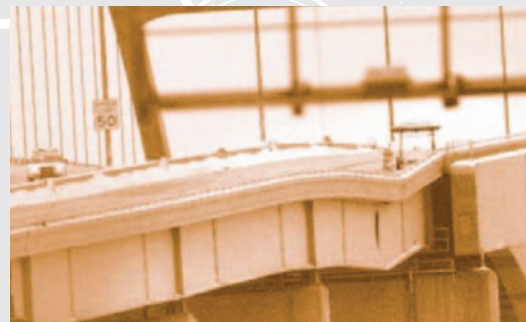
Small, previously monitored brittle cracks in the Hoan Bridge support span girder webs rapidly propagated on a cold December morning during a period of heavy vehicle traffic.

Routine inspections identified cracking at several locations in the girder webs of the support spans. These were deemed non-critical and monitored closely with limits set on allowable traffic while a comprehensive repair plan was developed. On December 13th, 2000, before repairs could be implemented, a 217 foot section of the bridge began to sag as a major brittle crack rapidly propagated through one of the girders.

Subsequent analysis identified an unusually high degree of constraint to normal expansion and contraction, and a geometric stress riser, at weld intersections of the fabricated span. A combination of extremely cold weather, heavy vehicle traffic, and the temperature gradient between the lake and inland side of the structure may all have added their cumulative affects.

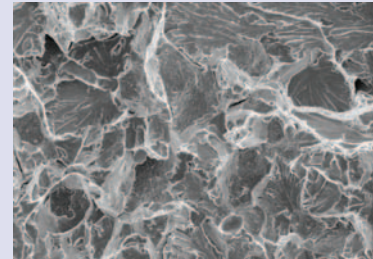
MAI service life analysis of a municipal electric power utility's generator rotor, included evaluation of the DBTT by Charpy Impact testing at a range of temperatures. Our conclusions were used to plan cost saving maintenance programs.

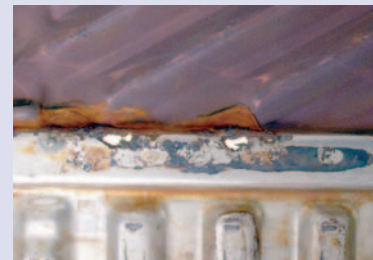
Analysis of a failed plate heat exchanger used in a pharmaceutical processing plant. Our evaluation determined that the failure was caused by degradation of attached components, rather than any deficiency in our client's plate heat exchanger.

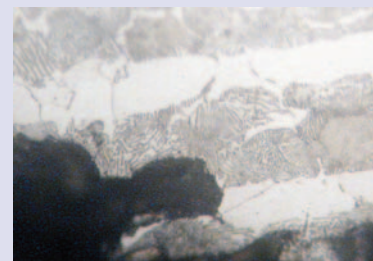
Our investigation of failed power transmission take-off shafts revealed fundamental processing defects in heat treating that were easily and inexpensively resolved.

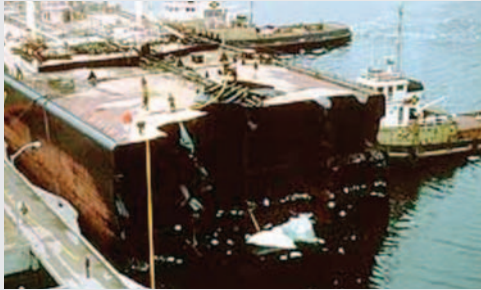
Despite breaking completely in two at sea, the MV Kurdistan miraculously made it back to port. Or at least half of it did. The bow section sank shortly after the sequential failure of the keel, hull plates and deck.

The estimated temperature of the oil on board was approximately 140° F, apparently due to extraction processing just prior to loading. The air temperature was 32° F and the water temperature was not much higher. Thermal stresses from of this temperature differential resulted in high tensile stresses on the hull and bilge keel structures.

The Kurdistan was designed to withstand these stresses, but not the weld defects present in the bilge keel resulting from a flawed repair two years earlier. Lack of weld penetration at this butt joint produced a stress riser which initiated a brittle fracture. Once initiated, the thermal driven tensile stresses and rough seas contributed to rapid fracture propagation through the hull and deck plates and breakup of the ship.
